Town of Northbridge Self-Evaluation and Transition Plan June 2022

TOWN OF NORTHBRIDGE – SELF-EVALUATION AND TRANSITION PLAN TABLE OF CONTENTS

This ADA Self-evaluation and Transition Plan ("Accessibility Plan" hereafter) includes model policies and procedures for adoption by the Town as well as barrier removal solutions for the Town's public buildings and facilities. The assessment of physical barriers and subsequent recommendations are based on the current 2010 ADA Standards for Accessible Design (2010 ADA Standards) and MA State Building Code 521 C.M.R., the higher standard to prevail. Although there are exceptions and variations (described below), this Accessibility Plan and its recommendations are based on compliance with the current Federal and State standards and the measures required to do so.

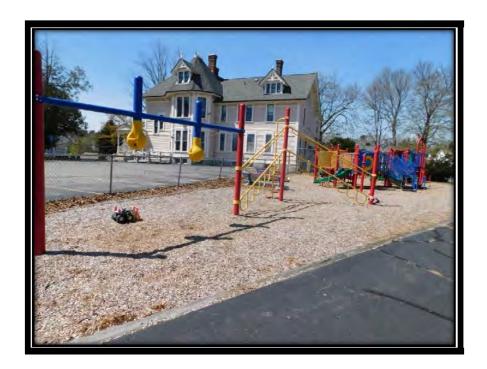
General Description or Obstacle Which Limits Mobility or Access: The chain link gate to enter the playground is not smooth at the base. The walkway from the sidewalk to the playground has a running slope of up to 12.0%. There is no accessible route of travel fully around the entirety of the playground (one side only). There is no accessible route of travel to the play equipment, sandbox, and bench. Noncompliant wood chips are the primary surface throughout the playground. There are no accessible play components.

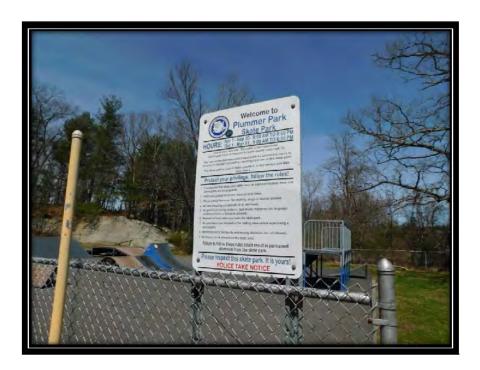
General Description or Obstacle Which Limits Mobility or Access: The chain link gate to enter the abandoned ballfield is not smooth at the base. There is no improved accessible route of travel to the skate park, memorial bench and portable toilet. The portable toilet is not accessible.

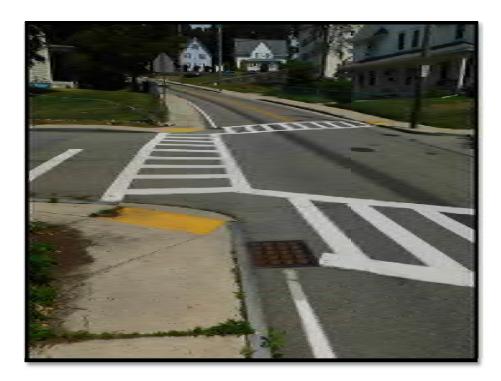
• The crosswalk at Crescent Street and North Main Street has 2 catch basins within the painted crosswalk area with grate openings of 3½" x 4½", which exceeds that allowed within an accessible route of travel

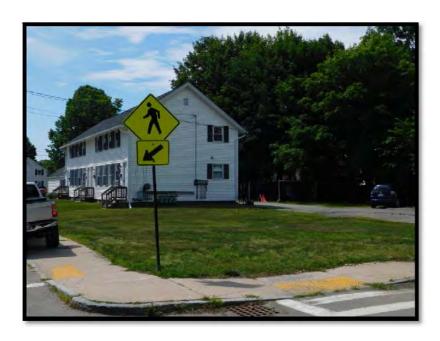
- Crossing signage at B Street is a protruding object at 74" a.f.f. with an 11" protrusion into the accessible route of travel
- Crossing signage at A Street (2 signs) are protruding objects at 70" and 72"a.f.f. with 9" protrusions into the accessible route of travel

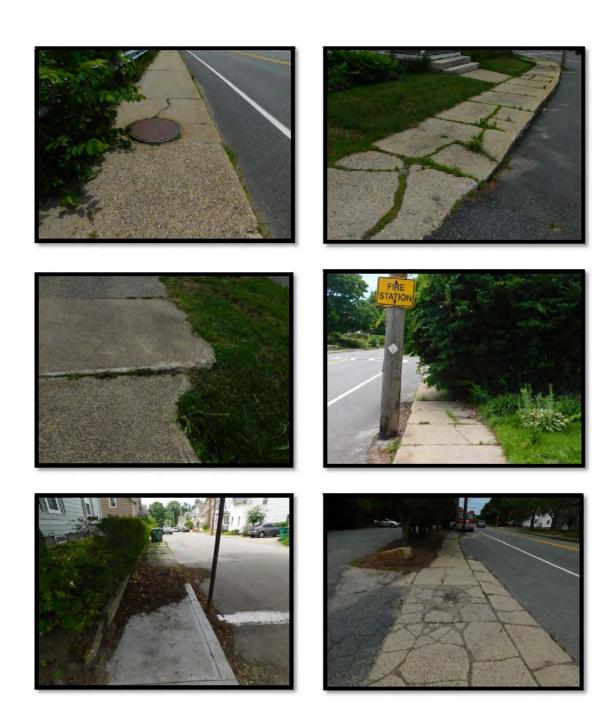
- Severe sidewalk deterioration, heaving, and/or abrupt changes in level surface at the sidewalk
 across from CoreMark, manhole cover in sidewalk opposite CoreMark (up to 1" change in level
 surface), sidewalk at #254/#252, sidewalk at #253/#254, sidewalk at the Fire Station (especially
 in the driveway area), sidewalk at Core Concepts parking, sidewalk at EAW and Access
- Sidewalk clear width at #253/#255 reduced to only 30" due to sidewalk deterioration
- Driveway cross slope at #203 varies from 3.4% to 4.0%
- Severe vegetative over growth at #231/#233 protrudes into the accessible route of travel
- Accumulation of debris on the Oak Street sidewalk eliminates the accessible route of travel in entirety
- Various debris on the sidewalk adjacent to Core Concepts creates an unstable surface

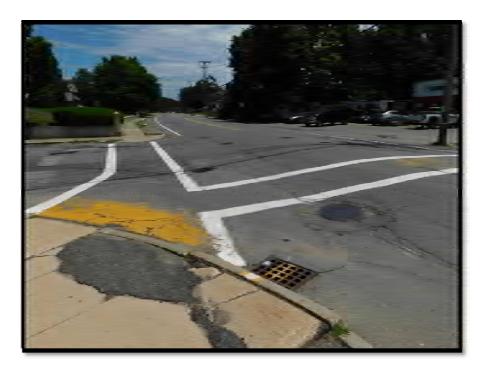
• An "apex" crossing at Cross and Linwood empties into the street on the Cross Street side
