Town of Northbridge Self-Evaluation and Transition Plan June 2022

TOWN OF NORTHBRIDGE – SELF-EVALUATION AND TRANSITION PLAN TABLE OF CONTENTS

This ADA Self-evaluation and Transition Plan ("Accessibility Plan" hereafter) includes model policies and procedures for adoption by the Town as well as barrier removal solutions for the Town's public buildings and facilities. The assessment of physical barriers and subsequent recommendations are based on the current 2010 ADA Standards for Accessible Design (2010 ADA Standards) and MA State Building Code 521 C.M.R., the higher standard to prevail. Although there are exceptions and variations (described below), this Accessibility Plan and its recommendations are based on compliance with the current Federal and State standards and the measures required to do so.

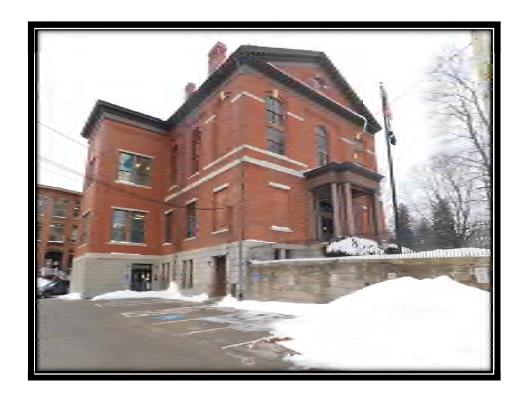
NORTHBRIDGE TOWN HALL

General Description or Obstacle Which Limits Mobility or Access: The town hall is moderately accessible compliant but does have some significant areas of non-compliance.

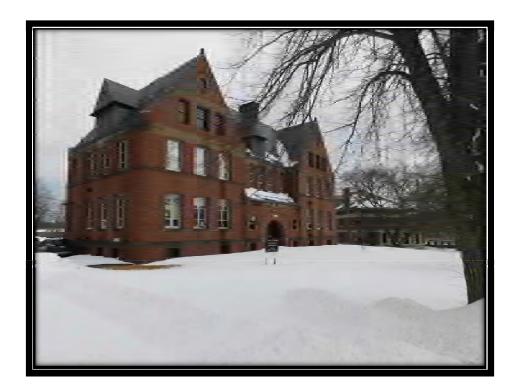
TOWN HALL ANNEX

General Description or Obstacle Which Limits Mobility or Access: The town hall annex is moderately accessible compliant for building access and for the first floor level. There is no vertical access to the second or third levels other than stairs.

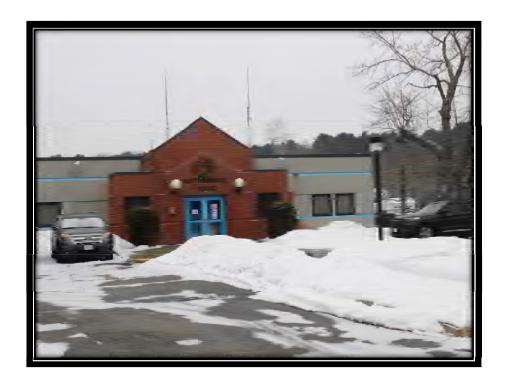
General Description or Obstacle Which Limits Mobility or Access: The Police Station is moderately accessible compliant with a number of areas of non-compliance.

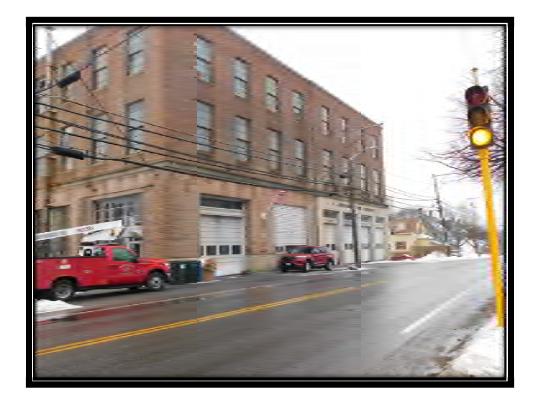
General Description or Obstacle Which Limits Mobility or Access: The Fire Station is substantially non-compliant even for those areas that are open to the public.

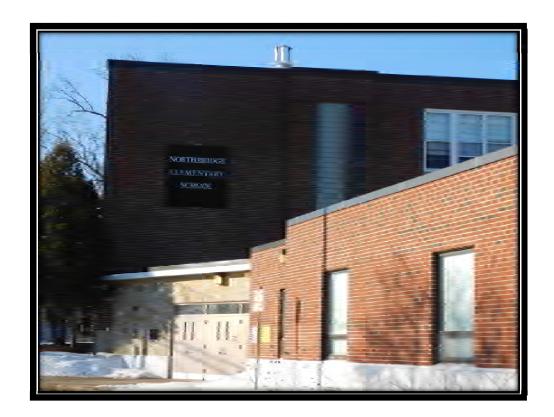
FORMER NORTHBRIDGE ELEMENTARY SCHOOL

General Description or Obstacle Which Limits Mobility or Access: The former elementary school building is predominately non-compliant under both the 2010 ADA Standards for Accessible Design and the 521 CMR Massachusetts Architectural Access Board Regulations.

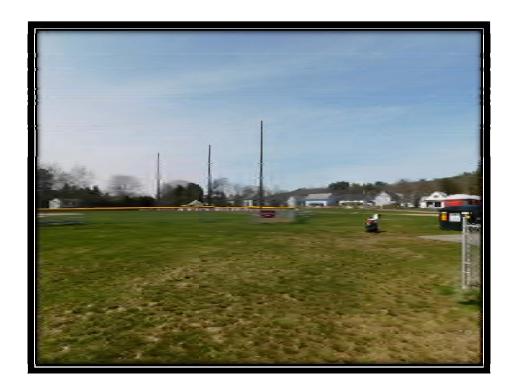
ROCKDALE MEMORIAL PARK

General Description or Obstacle Which Limits Mobility or Access: There lacks an accessible route of travel to the swings, concession stand, ballfields, bleachers, batting cages, and portable accessible toilet. There is reduced clear width at the entrance (s) into the facility. The dugouts next to the concession stand have 4" abrupt changes in level surface to access, reduced clear width to one dugout and chain link gates which are not smooth at the base. The concession stand has a 3" abrupt change in level surface to enter and 4" to 8" abrupt changes in level surface to access the outside service counters. The 2 counters are also 7" to 9" too high. The "accessible" portable toilet is not ADA compliant. There is no designated accessible parking in the adjacent paved parking.

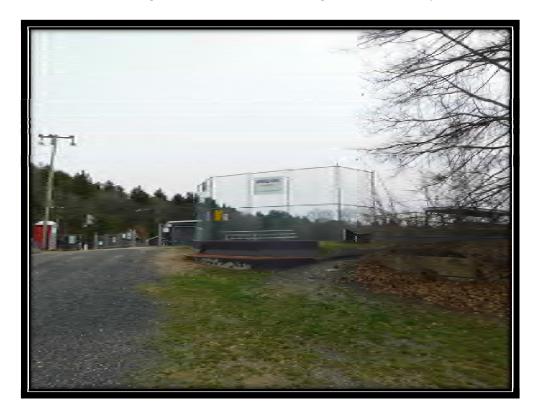
LINWOOD FIELD

General Description or Obstacle Which Limits Mobility or Access: There is no accessible route of travel to the recreational facility or to the swings, concession stand, ballfields, basketball courts, bleachers, bench, and accessible toilet. There is no designated accessible parking. The interior of the concession stand is only accessible by a set of stairs, which lack railings. The concession stand counter is 19½" too high. The portable toilet is not accessible.

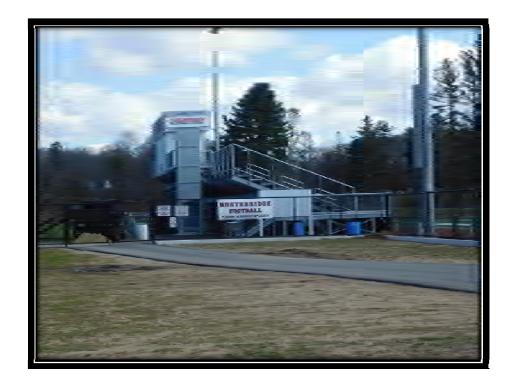
LASELL FIELD AND BASEBALL FIELDS

General Description or Obstacle Which Limits Mobility or Access: There is no accessible route of travel to the 2 baseball fields, baseball bleachers and dugouts. The baseball bleachers lack a level area for a wheelchair. There is a 3" abrupt change in level surface to access the interior of the concession stand. The concession stand sinks lack knee clearance and a towel dispenser is 13" too high. The concession stand service counters (2) are 14" to 14½" too high. The portable toilets (2) are not accessible and only one is on an accessible route of travel. The chain link gate to the track and multi-purpose field is not smooth at the base. The last 4 feet at the bottom of the ramp to the bleachers has a running slope of 8.5%, which exceeds the maximum allowed of 8.3%. The door into the broadcast booth has a glass pane that exceeds the maximum allowed height by 14".

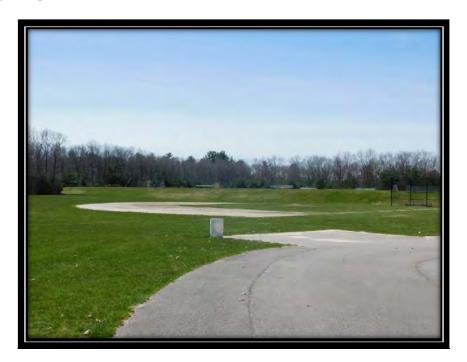
HIGH SCHOOL ATHLETIC FIELDS

General Description or Obstacle Which Limits Mobility or Access: There is no accessible route of travel fully around the soccer fields and baseball field and to player benches and bleacher seating. The designated accessible parking lacks signage and lacks van designated spaces. The portable "accessible" toilet is not on an accessible route of travel and is not ADA compliant. The stairs to the facility are not uniform and lack railings. Although the chain link gate at the entrance lacks a smooth surface at the base, it is not on an accessible route of travel so no further action is required.
